**Flood Control Project Maintenance
Levee Inspections****LMA District Cover Sheet****Spring 2016 Levee Inspection Results****Reclamation District No. 0404 Boggs**

Spring 2016 Levee Inspection Results

Reclamation District No. 0404 Boggs

Waterway			Bank	Unit Miles
Unit No. 01 San Joaquin River			Right	2.35
	Spring (March - May)	Summer (June - August)	(September - November) Fall	Winter (December - February)
Unit Maintenance Rating (Fall Only)				
Date of Inspection	4/7/2016 - 4/7/2016			
DWR Inspector	Richard Willoughby			
Accompanied By	Bob Winter KSN

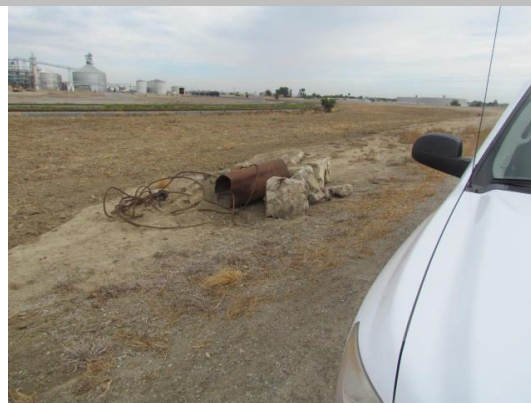
Photo 1 of 1 : SP_2016_RD0404_305_31_20160404_00021.jpg

Looking southeast at concrete blocks on landward slope.

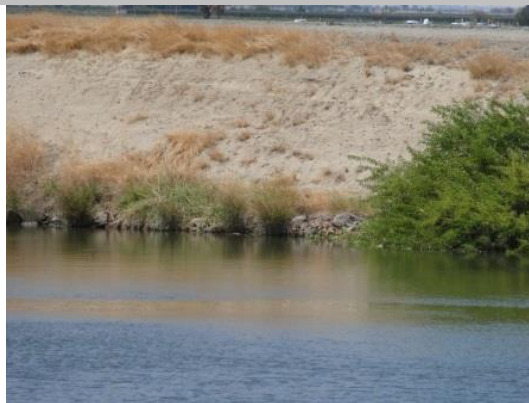
Photo 1 of 2 : SP_2016_RD0404_305_9_20160404_00010.jpg

LM Start	0.34	Rating **	U	Issue No.	9	
LM End	0.34	Issue Type +	Ma	Location *	WS	
Category	Supplemental			GPS Latitude/Longitude		
				Start	End	
Item	DWR Erosion Survey			37.939190 °	37.939190 °	
				-121.338280 °	-121.338280 °	
DWR ID	DWR_RD0404_01_s_2016_9					
Comment Code						
Inspector Comment						
06/24/2015: No significant change observed. 6/19/2014: No significant change observed. 08/13/2013: No significant change at this site. 8/7/2012: The erosion is next to a repaired site and approximately 400 feet downstream of a river bend. There are broken concretes at the upper levee slope, but not visible at the levee toe or lower slope. Likely the protection concrete blocks have been washed away. [2015 Site ID:RD0404U01RM41.11]

Close view of the site.

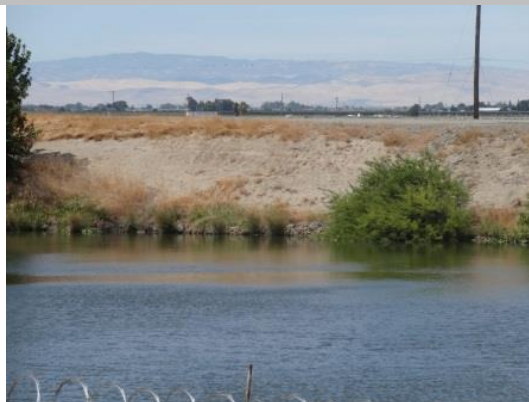
Photo 2 of 2 : SP_2016_RD0404_305_9_20160404_00011.jpg

A closer view of the site.

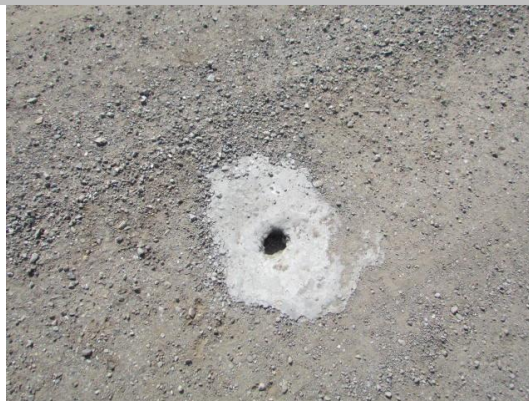
Photo 1 of 4 : SP_2016_RD0404_305_5_20160404_00004.jpg

LM Start	0.43	Rating **	M	Issue No.	5
LM End	0.43	Issue Type +	Ma	Location *	CR
Category	Earthen Levee			GPS Latitude/Longitude	
				Start	End
Item	Animal Control			37.939635 °	37.939635 °
				-121.339063 °	-121.339063 °
DWR ID	DWR_RD0404_01_s_2013_5				
Comment Code					
A3 : No rodents visible, but rodent burrows visible; need to backfill and compact or grout burrows.					
Inspector Comment					
District grouted hole, and the deficiency still exist.

Looking at partialled grouted rodent hole on levee crown (Fall 2014).

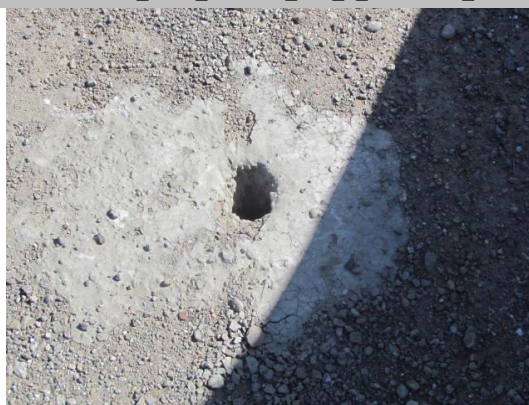
Photo 2 of 4 : SP_2016_RD0404_305_5_20160404_00005.jpg

Looking at partially grouted rodent hole on levee crown

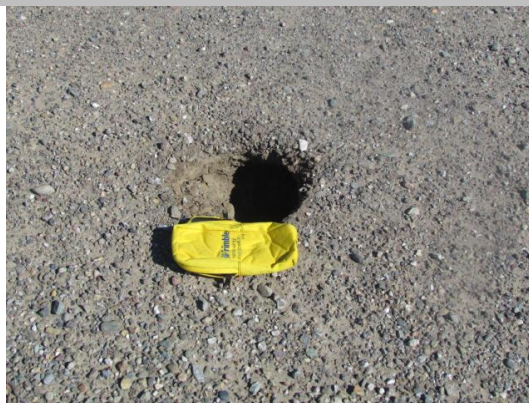
Photo 3 of 4 : SP_2016_RD0404_305_5_20160404_00006.jpg

Looking at rodent hole on levee crown.

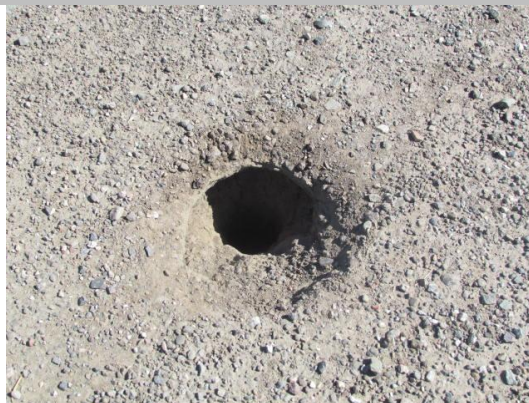
Photo 4 of 4 : SP_2016_RD0404_305_5_20160404_00007.jpg

LM Start	0.43	Rating **	M	Issue No.	5 (cont)	
LM End	0.43	Issue Type +	Ma	Location *	CR	
Category	Earthen Levee			GPS Latitude/Longitude		
				Start		End
Item	Animal Control			37.939635 °		37.939635 °
				-121.339063 °		-121.339063 °
DWR ID	DWR_RD0404_01_s_2013_5					
Comment Code						
A3 : No rodents visible, but rodent burrows visible; need to backfill and compact or grout burrows.						
Inspector Comment						
District grouted hole, and the deficiency still exist.

Looking at one of several rodent holes on levee crown.

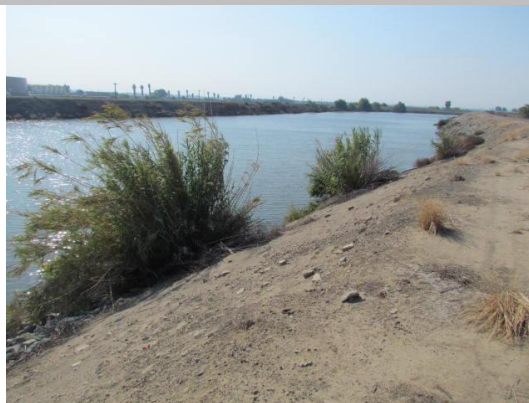
Photo 1 of 3 : SP_2016_RD0404_305_104_20160404_00024.jpg

LM Start	0.45	Rating **	A/W	Issue No.	104
LM End	0.45	Issue Type +	Ma	Location *	WS
Category	Earthen Levee			GPS Latitude/Longitude	
				Start	End
Item	Vegetation			37.939627 °	37.939627 °
				-121.338808 °	-121.338808 °
DWR ID	DWR_RD0404_01_s_2012_104				
Comment Code					
V2 : Remove the wild growth other than native grasses from the levee slopes.					
Inspector Comment					
Remove bamboo on waterside toe. Bamboo is not within twenty feet zone, but should be removed to stop from spreading along waterward slope. Bamboo has increased in size.

Looking northwest at bamboo on waterside toe.

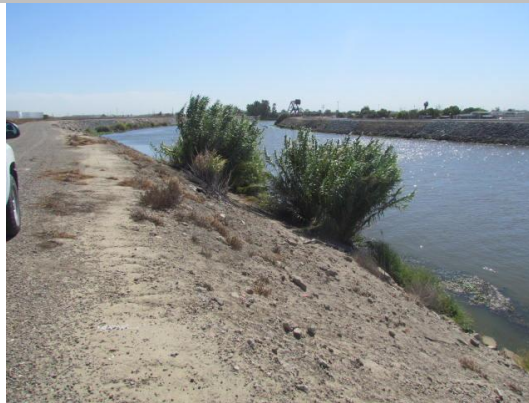
Photo 2 of 3 : SP_2016_RD0404_305_104_20160404_00025.jpg

Looking west at bamboo on waterward slope. 2013

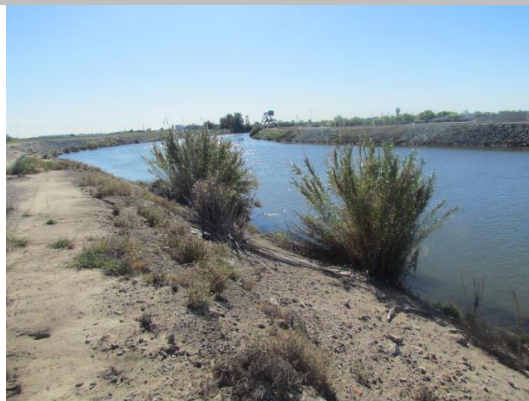
Photo 3 of 3 : SP_2016_RD0404_305_104_20160404_00026.jpg

Looking southwest at bamboo on waterward slope and toe.

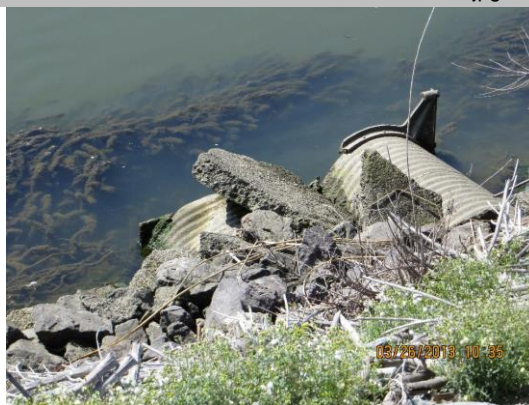
Photo 1 of 2 : UCIP_SP_2016_40783_20082.jpg

LM Start	0.48	Rating **	U	Issue No.	111
LM End	0.48	Issue Type +	En	Location *	WS
Category	Supplemental			GPS Latitude/Longitude	
				Start	End
Item	DWR UCIP Field Study			37.939640 °	37.939640 °
				-121.338175 °	-121.338175 °
DWR ID					
Comment Code					
Inspector Comment					
FS_ID:40783					
DS_ID:22968					
EP_NO: N/A					
Repair Type: Urgent					
Crossing Status: Found					
UCIP Comments: Flap gate missing from WS toe.					
FIELD_STRUCT_DESC: 1 of 2. Two 36-inch corrugated metal drainage pipes.					
FS Date: 3/26/2013

WS- two CM pipes with damaged flap gates

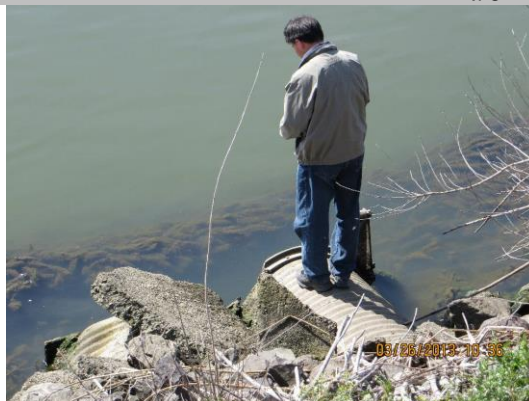
Photo 2 of 2 : UCIP_SP_2016_40783_20081.jpg

LM Start	0.48	Rating **	U	Issue No.	111 (cont)	
LM End	0.48	Issue Type +	En	Location *	WS	
Category	Supplemental			GPS Latitude/Longitude		
				Start		End
Item	DWR UCIP Field Study			37.939640 °		37.939640 °
				-121.338175 °		-121.338175 °
DWR ID						
Comment Code						
Inspector Comment						
FS_ID:40783						
DS_ID:22968						
EP_NO: N/A						
Repair Type: Urgent						
Crossing Status: Found						
UCIP Comments: Flap gate missing from WS toe.						
FIELD_STRUCT_DESC: 1 of 2. Two 36-inch corrugated metal drainage pipes.						
FS Date: 3/26/2013

WS- left CM pipe with missing flap gate

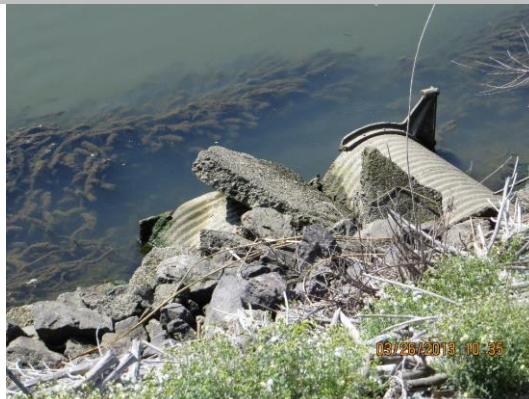
Photo 1 of 2 : UCIP_SP_2016_40784_20086.jpg

LM Start	0.48	Rating **	U	Issue No.	112
LM End	0.48	Issue Type +	En	Location *	WS
Category	Supplemental			GPS Latitude/Longitude	
				Start	End
Item	DWR UCIP Field Study			37.939640 °	37.939640 °
				-121.338175 °	-121.338175 °
DWR ID					
Comment Code					
Inspector Comment					
FS_ID:40784					
DS_ID:22969					
EP_NO: N/A					
Repair Type: Urgent					
Crossing Status: Found					
UCIP Comments: Pipe has broken flap gate.					
FIELD_STRUCT_DESC: 2 of 2. Two 36-inch corrugated metal drainage pipes.					
FS Date: 3/26/2013

WS- two CM pipes with damaged flap gates

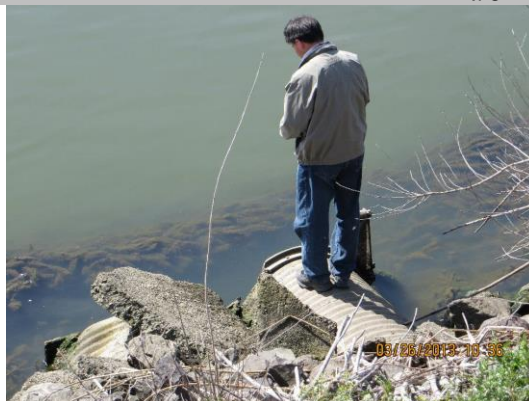
Photo 2 of 2 : UCIP_SP_2016_40784_20085.jpg

LM Start	0.48	Rating **	U	Issue No.	112 (cont)	
LM End	0.48	Issue Type +	En	Location *	WS	
Category	Supplemental			GPS Latitude/Longitude		
				Start		End
Item	DWR UCIP Field Study			37.939640 °		37.939640 °
				-121.338175 °		-121.338175 °
DWR ID						
Comment Code						
Inspector Comment						
FS_ID:40784						
DS_ID:22969						
EP_NO: N/A						
Repair Type: Urgent						
Crossing Status: Found						
UCIP Comments: Pipe has broken flap gate.						
FIELD_STRUCT_DESC: 2 of 2. Two 36-inch corrugated metal drainage pipes.						
FS Date: 3/26/2013

WS- right CM pipe with damaged flap gate

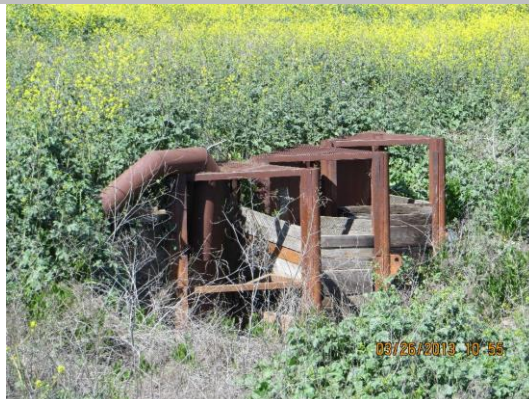
Photo 1 of 2 : UCIP_SP_2016_11087_20041.jpg

LM Start	0.65	Rating **	M	Issue No.	108
LM End	0.65	Issue Type +	En	Location *	WS
Category	Supplemental			GPS Latitude/Longitude	
				Start	End
Item	DWR UCIP Field Study			37.938670 °	37.938670 °
				-121.335397 °	-121.335397 °
DWR ID					
Comment Code					
Inspector Comment					
FS_ID:11087					
DS_ID:17952					
EP_NO: N/A					
Repair Type: Non-Urgent					
Crossing Status: Found					
UCIP Comments: Steel intake structure on landside of the levee.					
FIELD_STRUCT_DESC: 2 of 3. 30-inch pipes through levee, 22.0 feet below the crown. Waterward end with flap gates. Landward end filled with dirt. Steel intake structure on landside of the levee. Middle flap gate missing and right flap gate broken as of 1/24/07.					
FS Date: 3/26/2013

LS- intake structure

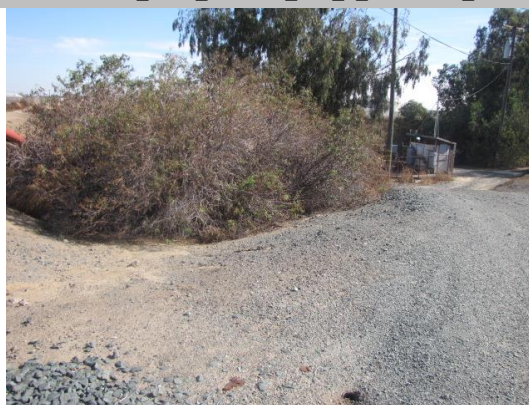
Photo 1 of 1 : SP_2016_RD0404_305_7_20160404_00008.jpg

Looking southeast at elderberry on landside slope.

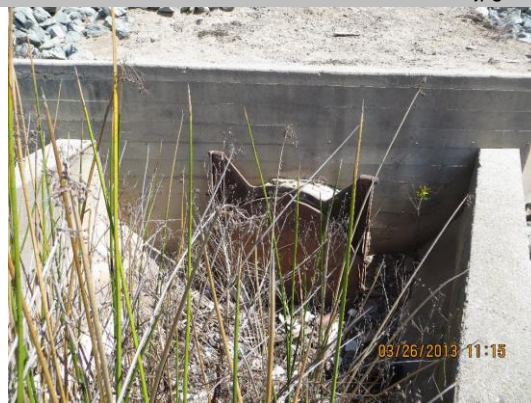
Photo 2 of 2 : UCIP_SP_2016_46628_19961.jpg

FS_ID:46628
DS_ID:17945
EP_NO: N/A
Repair Type: Urgent
Crossing Status: Found
UCIP Comments: Partially buried flap gate
FIELD_STRUCT_DESC: 42-inch CM drainage pipe 18.0 FBC. Flap gate, concrete headwall and spillway on WS. Pumphouse on LS.
Abandoned concrete headwall, power pole, and 2 wooden piles found on LS. O&M #: SJR 001
FS Date: 8/4/2015

WS- Debris and vegetation blocking CM drainage pipe

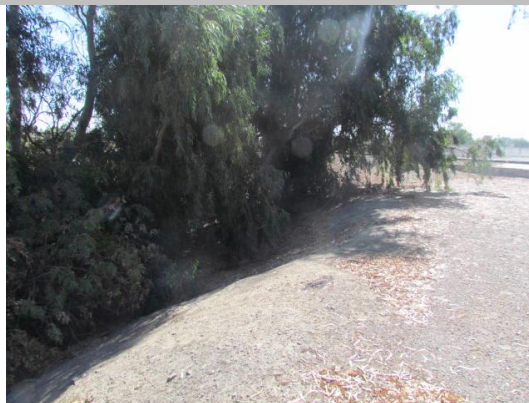
Photo 1 of 1 : SP_2016_RD0404_305_8_20160404_00009.jpg

Looking southeast at dense trees on landward slope and toe.

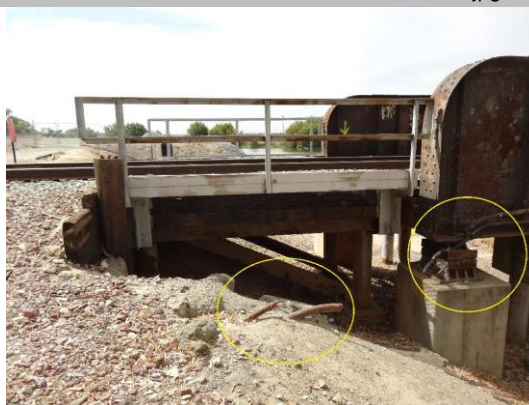
Photo 1 of 2 : UCIP_SP_2016_46810_74753.jpg

LM Start	0.79	Rating **	M	Issue No.	115
LM End	0.79	Issue Type +	En	Location *	LS
Category	Supplemental			GPS Latitude/Longitude	
				Start	End
Item	DWR UCIP Field Study			37.937212 °	37.937212 °
				-121.333762 °	-121.333762 °
DWR ID					
Comment Code					
Inspector Comment					
FS_ID:46810 DS_ID:17946 EP_NO: N/A Repair Type: Non-Urgent Crossing Status: Found UCIP Comments: Appears abandoned; if so should be done so properly. FIELD_STRUCT_DESC: Underground telephone cable through levee and across channel. Non-operational. FS Date: 8/4/2015

WS view looking south: conduits penetrating levee slope now disconnected with those attached to bridge

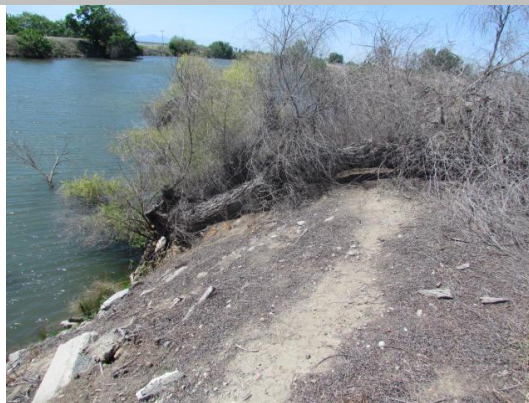
Photo 1 of 2 : SP_2016_RD0404_305_3_20160404_00001.jpg

Looking northwest at downed tree on waterward slope and shoulder.

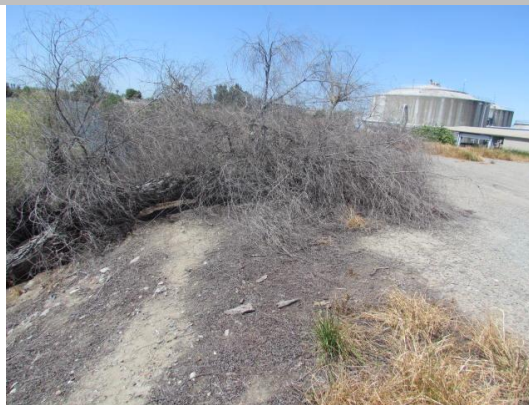
Photo 2 of 2 : SP_2016_RD0404_305_3_20160404_00002.jpg

Looking north at downed tree on waterward slope and shoulder.

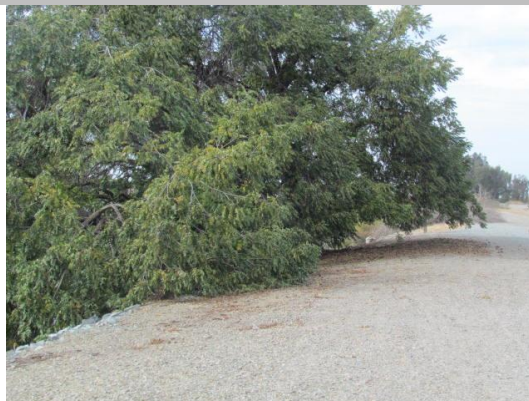
Photo 1 of 1 : SP_2016_RD0404_305_102_20160404_00023.jpg

Looking northwest at untrimmed tree on waterward slope.

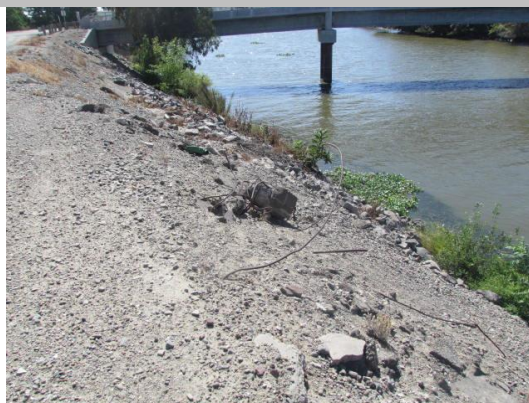
Photo 1 of 1 : SP_2016_RD0404_305_4_20160404_00003.jpg

Looking southwest at concrete rubble with rebar on waterward slope.

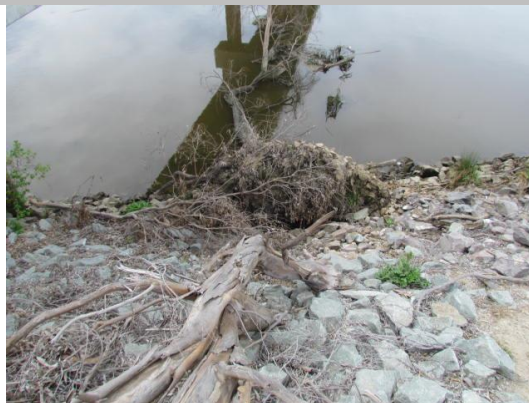
Photo 1 of 1 : SP_2016_RD0404_305_39_20160408_00062.jpg

Looking west at fallen tree with hole on waterward toe.

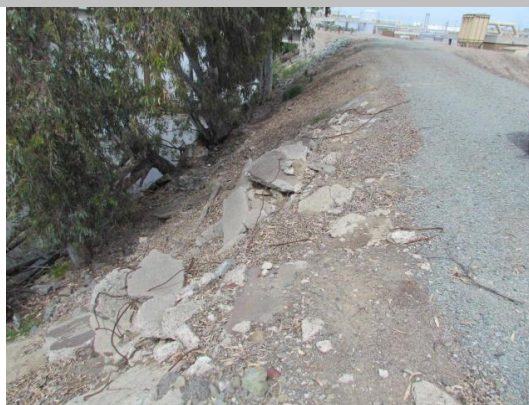
Photo 1 of 2 : SP_2016_RD0404_305_38_20160408_00063.jpg

Looking southwest at concrete rubble with rebar on waterward slope.

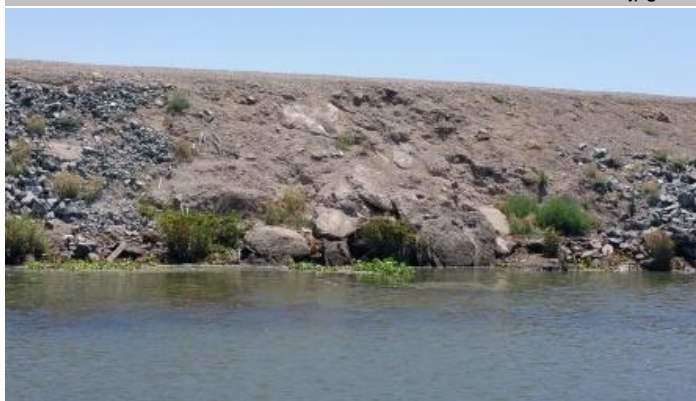
Photo 1 of 2 : SP_2016_RD0404_305_11_20160404_00012.jpg

LM Start	1.44	Rating **	M	Issue No.	11
LM End	1.46	Issue Type +	Ma	Location *	WS
Category	Supplemental			GPS Latitude/Longitude	
				Start	End
Item	DWR Erosion Survey			37.930450 °	37.930450 °
				-121.327450 °	-121.327450 °
DWR ID	DWR_RD0404_01_s_2016_11				
Comment Code					
Inspector Comment					
06/24/2015: No significant change observed.					
06/19/2014: A series of scarp erosions have been found on the lower levee slope and at the levee toe. [2015 Site ID:RD0404U01RM42.02]

Front view of the erosion.

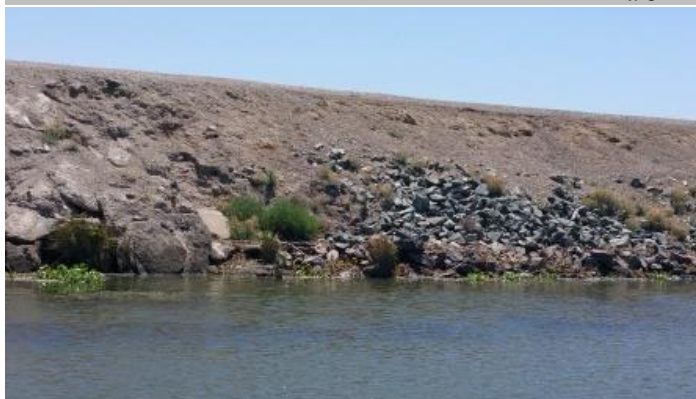
Photo 2 of 2 : SP_2016_RD0404_305_11_20160404_00013.jpg

LM Start	1.44	Rating **	M	Issue No.	11 (cont)	
LM End	1.46	Issue Type +	Ma	Location *	WS	
Category	Supplemental			GPS Latitude/Longitude		
				Start		End
Item	DWR Erosion Survey			37.930450 °	37.930450 °	
				-121.327450 °	-121.327450 °	
DWR ID	DWR_RD0404_01_s_2016_11					
Comment Code						
Inspector Comment						
06/24/2015: No significant change observed.						
06/19/2014: A series of scarp erosions have been found on the lower levee slope and at the levee toe. [2015 Site ID:RD0404U01RM42.02]

Close view of the erosion. The upstream end of the site is protected by riprap revetment.

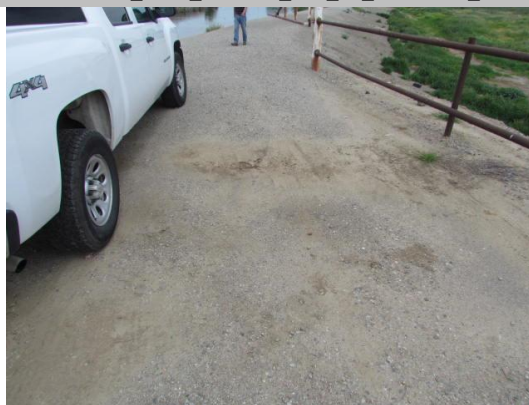
Photo 2 of 3 : SP_2016_RD0404_305_37_20160408_00058.jpg

Looking east at depression across levee crown.

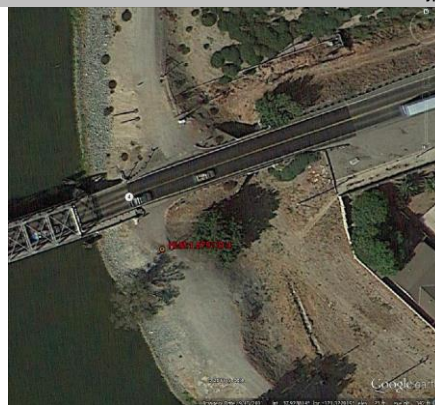
Photo 1 of 1 : UCIP_SP_2016_12386_20062.jpg

LM Start	1.57	Rating **	M	Issue No.	107
LM End	1.57	Issue Type +	En	Location *	CR
Category	Supplemental			GPS Latitude/Longitude	
				Start	End
Item	DWR UCIP Field Study			37.928718 °	37.928718 °
				-121.327206 °	-121.327206 °
DWR ID					
Comment Code					
Inspector Comment					
FS_ID:12386 DS_ID:17956 EP_NO: 15562 Repair Type: Non-Urgent Crossing Status: Found UCIP Comments: According to Bob Winter of KSN/LMA representative. Fiber optics cable goes through levee. No sign/indicators found. And photos not taken. FIELD_STRUCT_DESC: 4-inch steel pipe with fiber optics communication cable through levee. Cable Crosses the channel. (Permit No. 15562-1991). The pipe is 34 feet below the levee crown. FS Date: 3/26/2013

Aerial Photo @HLM=1.5791: No sign posts/markers found.

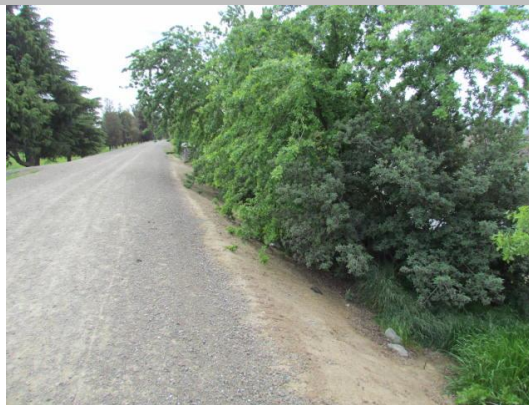
Photo 2 of 2 : SP_2016_RD0404_305_29_20160408_00065.jpg

Looking north at dense vegetation on waterward slope.

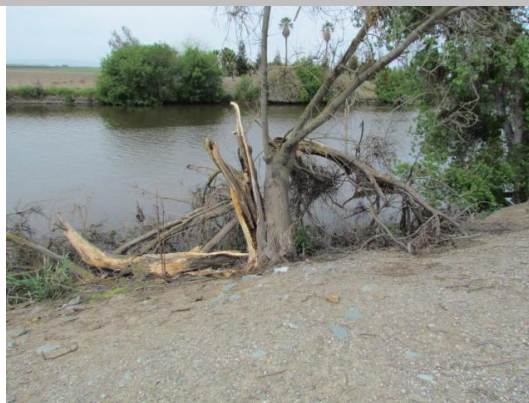
Photo 1 of 1 : SP_2016_RD0404_305_33_20160408_00067.jpg

Looking west at dead tree on waterward slope.

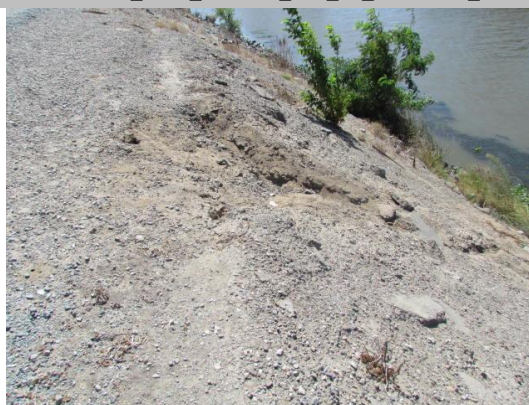
Photo 2 of 2 : SP_2016_RD0404_305_16_20160404_00015.jpg

Looking southwest at slope damage due to foot traffic.

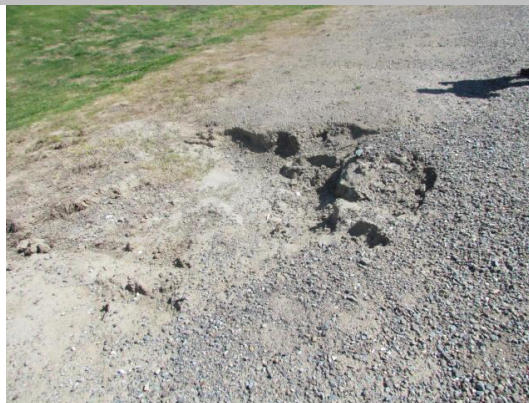
Photo 1 of 2 : SP_2016_RD0404_305_28_20160404_00018.jpg

Looking east at erosion on landward slope.

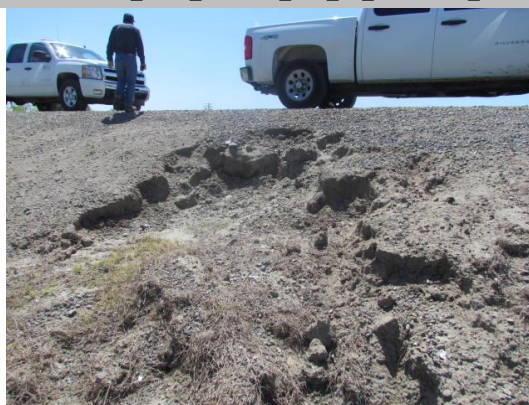
Photo 2 of 2 : SP_2016_RD0404_305_28_20160404_00019.jpg

Looking west at erosion on landward slope.

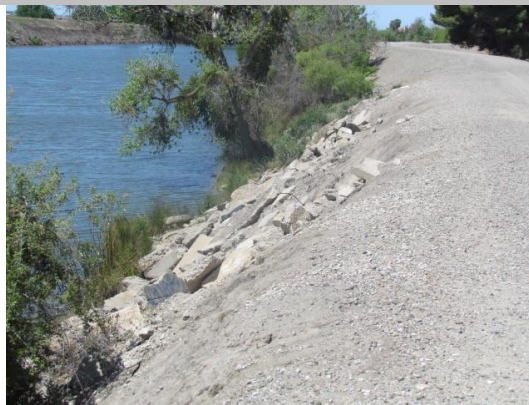
Photo 1 of 2 : SP_2016_RD0404_305_23_20160404_00016.jpg

Looking west at concrete rip rap with rebar. (Spring 2015)

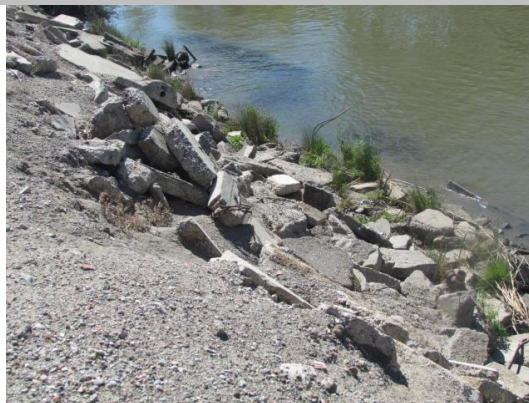
Photo 2 of 2 : SP_2016_RD0404_305_23_20160404_00017.jpg

Looking southwest at concrete rip rap with rebar.

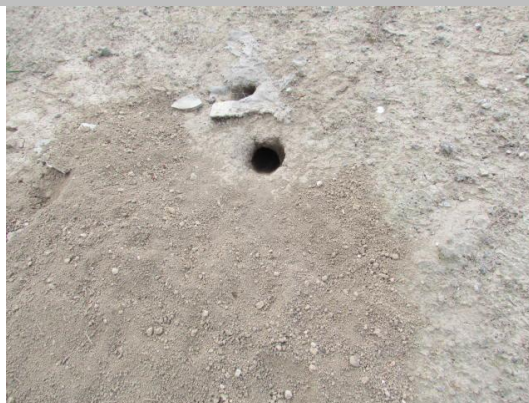
Photo 1 of 2 : SP_2016_RD0404_306_21_20160408_00024.jpg

Looking east at large rodent hole on landward slope.

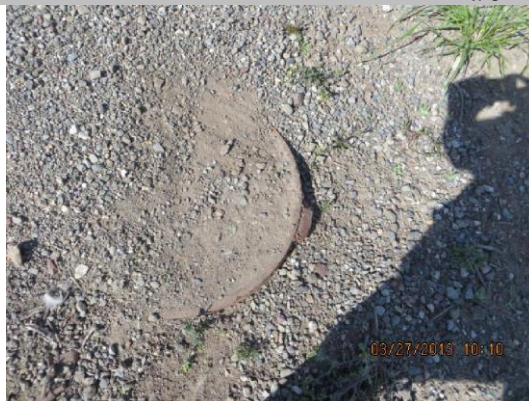
Photo 2 of 2 : UCIP_SP_2016_10908_18181.jpg

WS- damaged, obstructed and buried siphon breaker

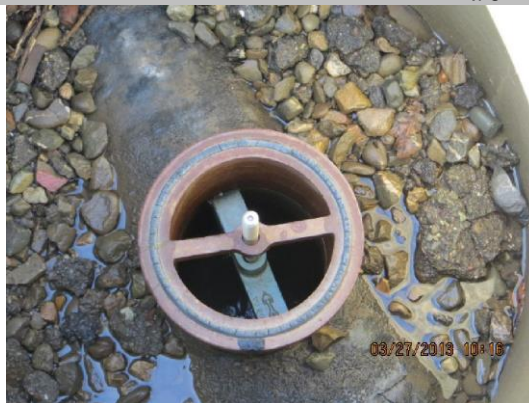
Photo 1 of 2 : UCIP_SP_2016_10945_18248.jpg

WS- siphon breaker without cap in concrete riser

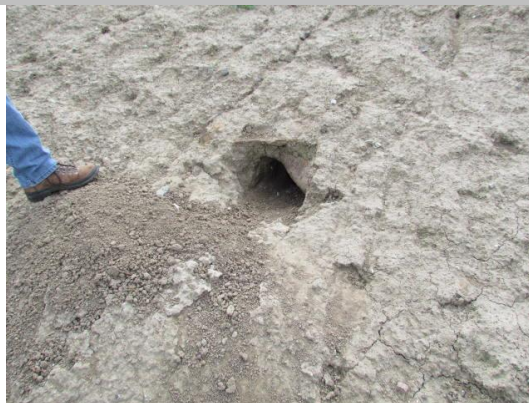
Photo 1 of 2 : SP_2016_RD0404_306_20_20160408_00026.jpg

Looking at rodent hole on levee crown.

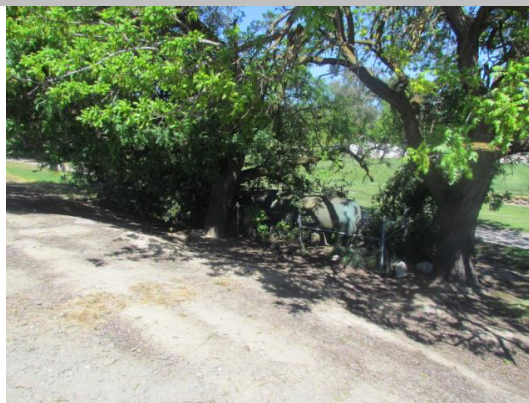
Photo 2 of 4 : SP_2016_RD0404_306_67_20160404_00006.jpg

Looking north at dense vegetation on landward toe around propane tank.

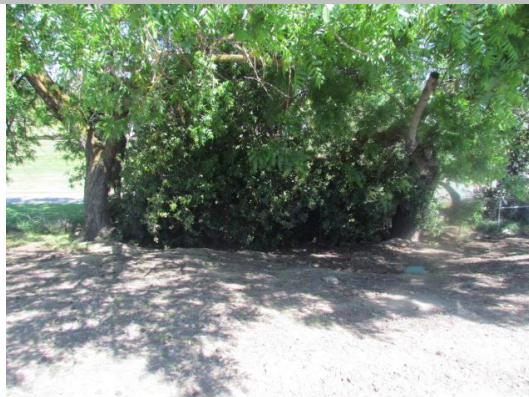
Photo 3 of 4 : SP_2016_RD0404_306_67_20160404_00007.jpg

Looking northeast at dense vegetation on landward toe. (Spring 2013)

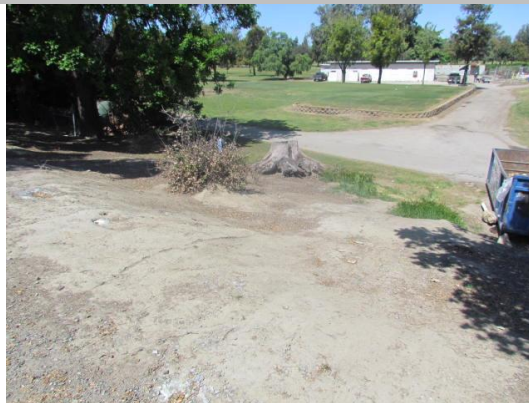
Photo 1 of 1 : SP_2016_RD0404_306_15_20160404_00004.jpg

Looking east at dead stump on landward toe.

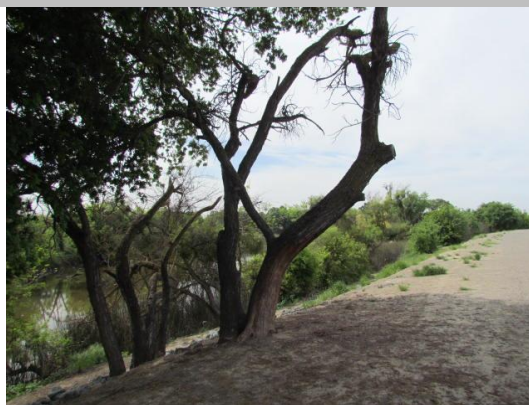
Photo 1 of 2 : SP_2016_RD0404_306_18_20160408_00028.jpg

Looking east at dead trees on waterward slope.

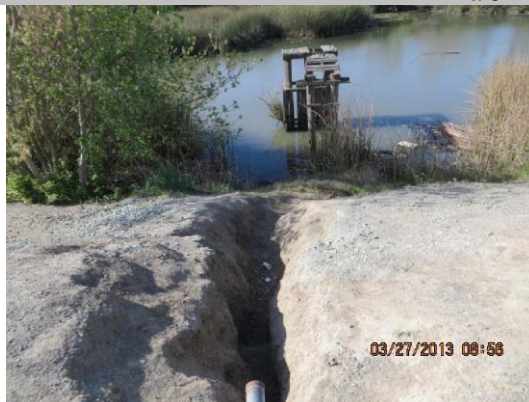
Photo 2 of 2 : UCIP_SP_2016_10853_18133.jpg

WS- soil erosion and gully formation due to leaky pipe
